# RV INSPECTION REPORT

September 30, 2026 / 2024 Tiffin Open Road Allegro 36 LA

VIN: SYNTHETIC-36LA

Honest Mans Mobile RV Inspections

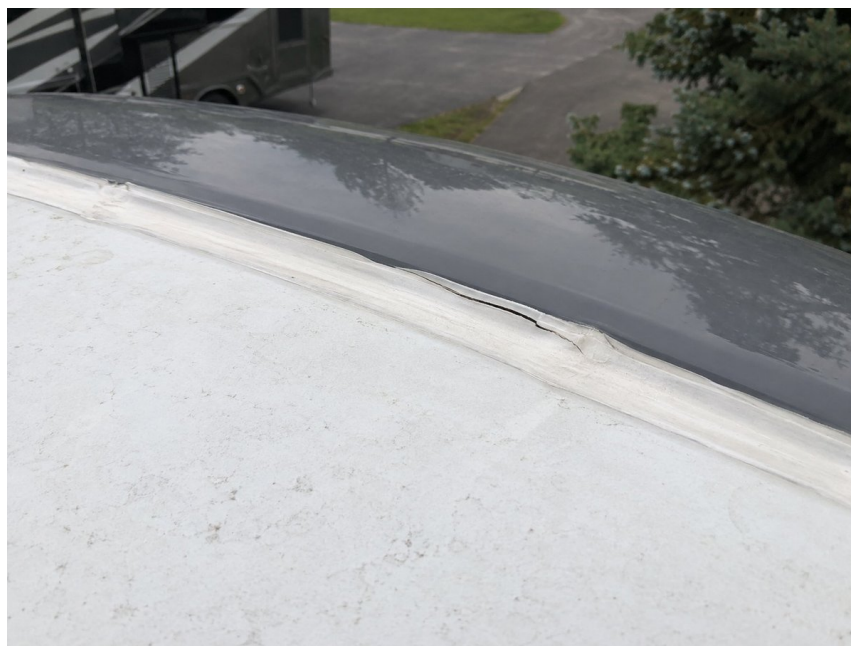
**3.1 Front cap, joints & seals****Poor**

Separation was observed in the lap sealant along the front cap-to-roof joint. Interior ceiling staining was present below the same area, and comparative moisture readings were elevated there relative to an adjacent dry reference area. The sealant separation can allow water intrusion. Concealed damage and the precise leak path were not determined.

Separation was observed in the lap sealant along the front cap-to-roof joint. Interior ceiling staining was present below the same area, and comparative moisture readings were elevated there relative to an adjacent dry reference area. The sealant separation can allow water intrusion. Concealed damage and the precise leak path were not determined. It is recommended that this be looked at by a qualified RV technician.

Illustration: Separation along the front cap-to-roof sealant joint.

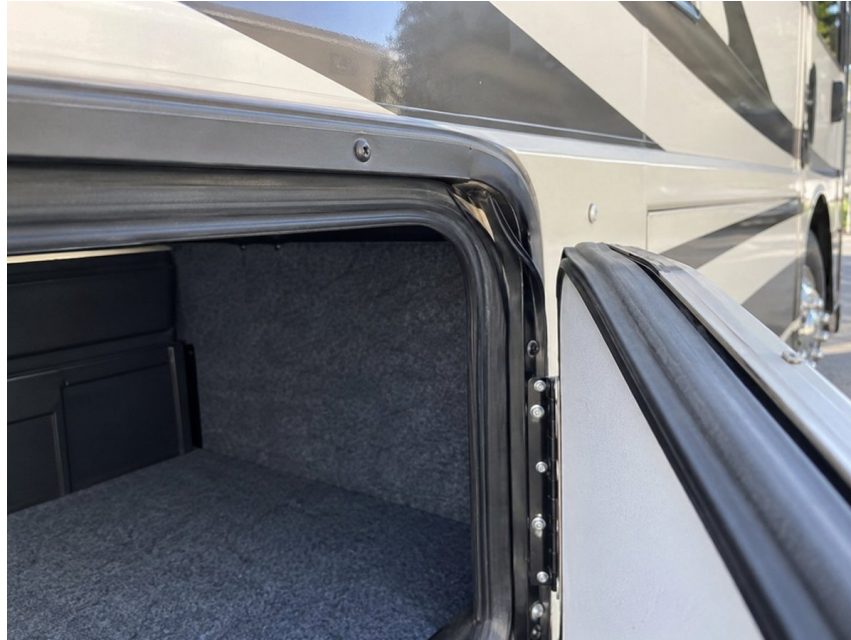
The weather seal at the upper corner of a curbside storage compartment door was pulled away from the frame. The door operated and latched, but the seal did not maintain continuous contact at that corner. This can allow water intrusion. It is recommended that this be looked at by a qualified RV technician.

Illustration: Separated storage-door weather seal at the upper corner.

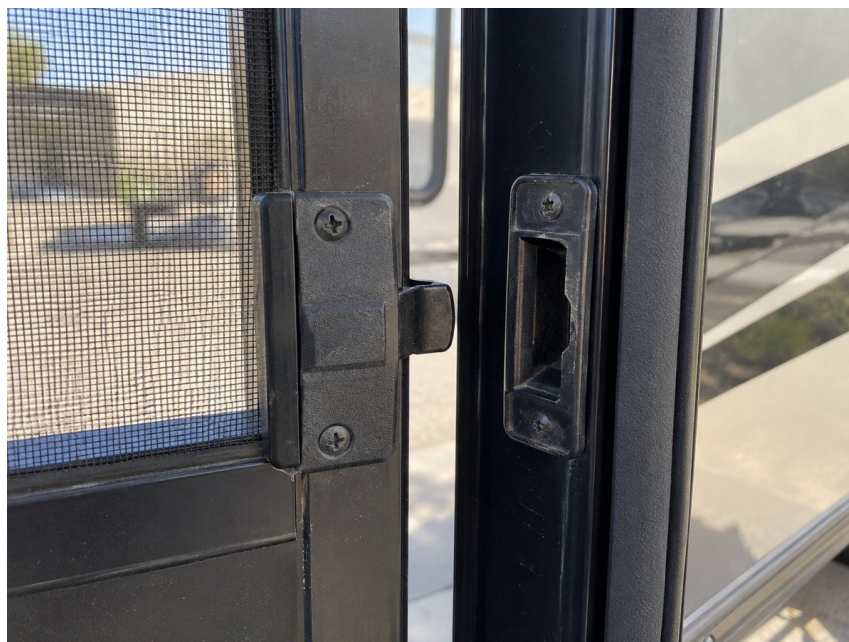
**9.3 Screen door operation****Fair**

The main entry screen door moved freely, but its latch did not engage the adjoining catch consistently. The screen door would not remain secured to the main entry door as intended. It is recommended that this be looked at by a qualified RV technician.

Illustration: Entry screen-door latch and adjoining catch.

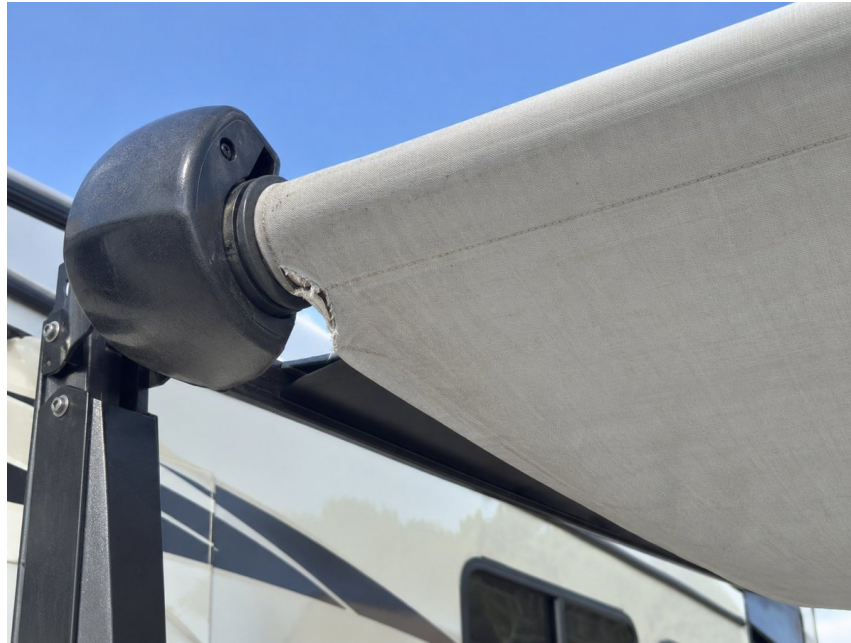
### 12.2 Front Patio Awning - Fabric - Condition

A small tear was observed near the outer edge of the patio awning fabric. The remaining visible fabric was attached, and the awning extended and retracted during the test in calm conditions.

A small tear was observed near the outer edge of the patio awning fabric. The remaining visible fabric was attached, and the awning extended and retracted during the test in calm conditions. It is recommended that this be looked at by a qualified RV technician.

Illustration: Localized tear near the patio awning roller edge.

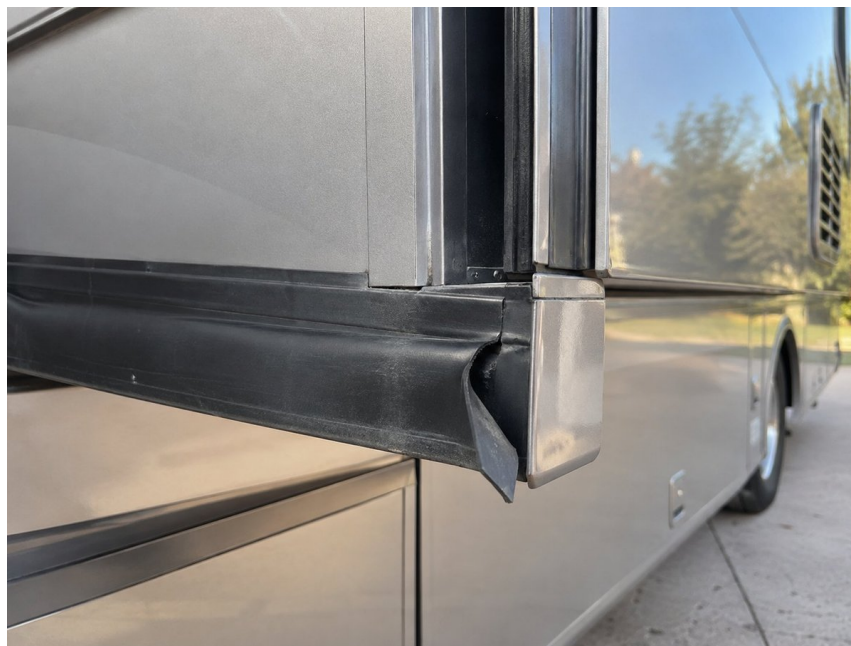
**13.44 Streetside Rear - Seals, Sweeps and Gaskets - Condition****Fair**

A localized tear was observed in the lower rubber sweep on the streetside rear bedroom slideout. The remainder of the visible sweep remained attached. The damaged area may reduce the seal at that location.

A localized tear was observed in the lower rubber sweep on the streetside rear bedroom slideout. The remainder of the visible sweep remained attached. The damaged area may reduce the seal at that location. It is recommended that this be looked at by a qualified RV technician.

Illustration: Localized tear in the lower slideout sweep.

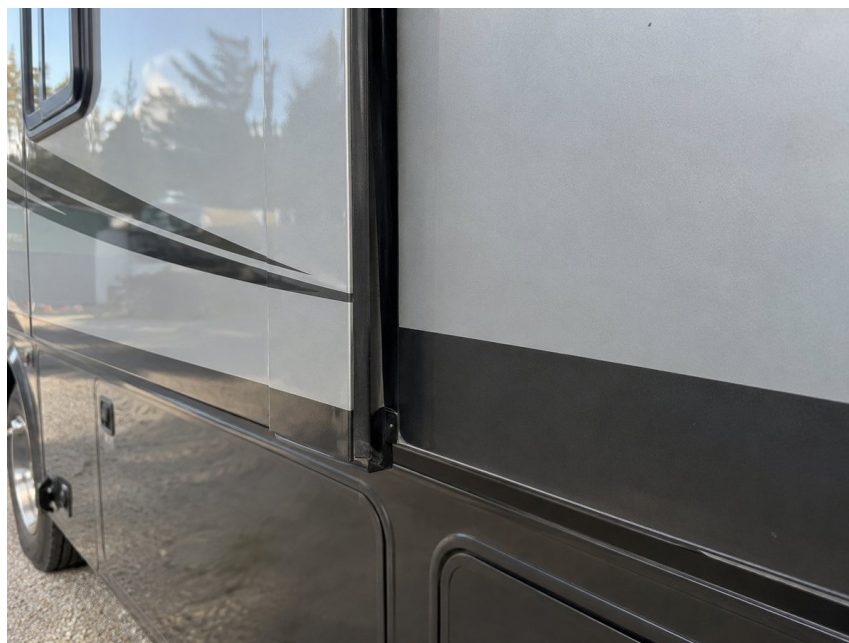
The streetside front living-room slideout traveled unevenly and did not seat fully against the sidewall when retracted. An uneven gap remained at the lower edge. Cycling was stopped when the misalignment became apparent; the room was not forced into position. It is recommended that this be looked at by a qualified RV technician.

Illustration: Uneven gap at the living-room slideout edge.

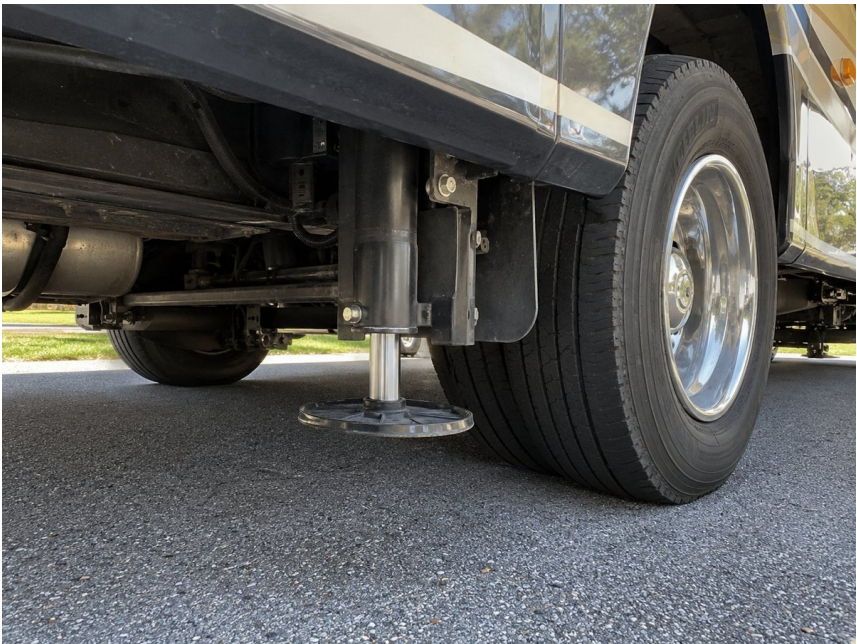
The hydraulic leveling jacks responded to the controls. After retraction, the streetside rear jack slowly moved downward from its stowed position during observation. Its pad did not remain at the same height as immediately after retraction. The cause was not determined.

The hydraulic leveling jacks responded to the controls. After retraction, the streetside rear jack slowly moved downward from its stowed position during observation. Its pad did not remain at the same height as immediately after retraction. The cause was not determined. It is recommended that this be looked at by a qualified RV technician.

Illustration: Hydraulic jack below its fully stowed position.

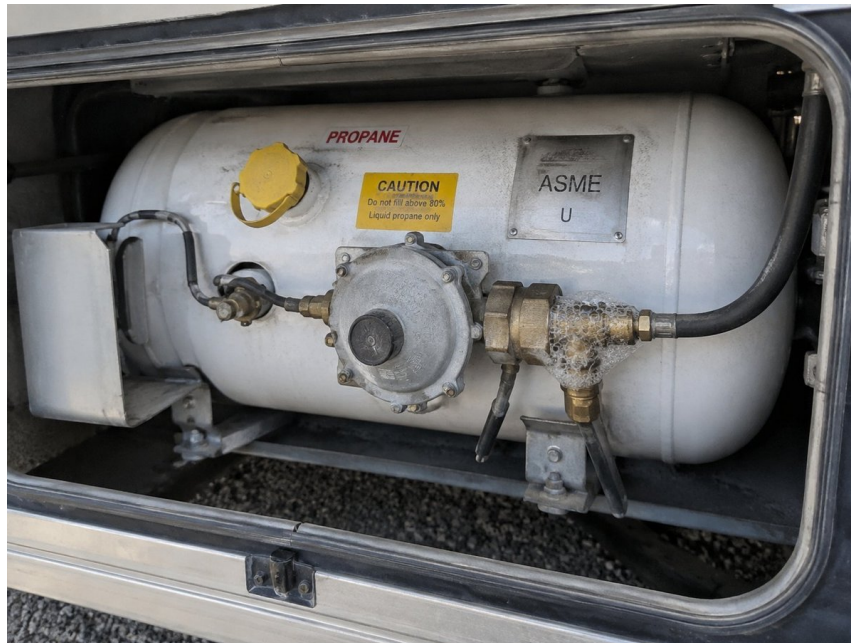
#### 22.0 LP Leak System Test

Leak-detection solution produced continuing bubbles at the accessible low-pressure regulator outlet connection. This indicates leakage at that connection. The propane supply was shut off, and propane appliance operation was not attempted. This condition presents a fire and explosion hazard.

Leak-detection solution produced continuing bubbles at the accessible low-pressure regulator outlet connection. This indicates leakage at that connection. The propane supply was shut off, and propane appliance operation was not attempted. This condition presents a fire and explosion hazard. It is recommended that this be looked at by a qualified RV technician before the RV is occupied.

Illustration: ASME tank and accessible regulator outlet connection.

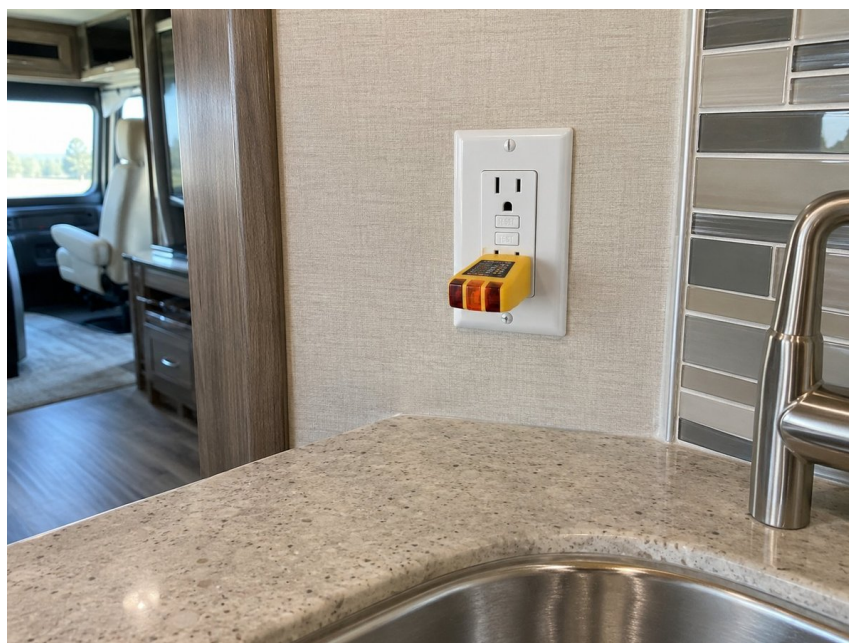
**24.13 GFCI Trip Testing - Kitchen Receptacles****Poor**

The GFCI protection serving the receptacle beside the kitchen sink did not interrupt power when tested. The receptacle remained energized during the test. This presents an electrical shock hazard. The affected receptacle was not used for further testing.

The GFCI protection serving the receptacle beside the kitchen sink did not interrupt power when tested. The receptacle remained energized during the test. This presents an electrical shock hazard. The affected receptacle was not used for further testing. It is recommended that this be looked at by a qualified RV technician before the RV is occupied.

Illustration: Kitchen receptacle and GFCI test setup; the functional result is described above.

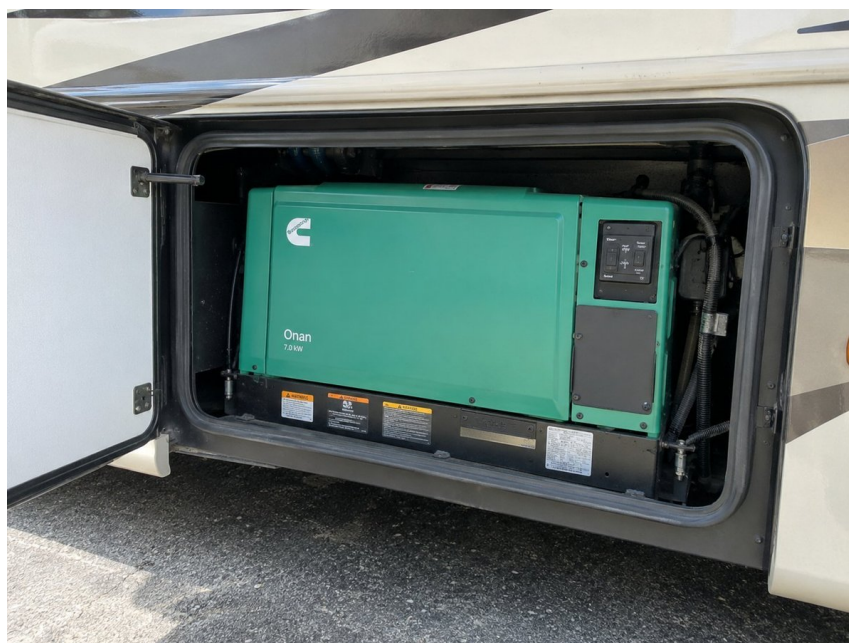
**24.48 Generator - Tested Under Load****Poor**

The gasoline generator started and ran without an applied coach load. It shut down shortly after a controlled electrical load was applied. The load was removed, and further loaded testing was stopped. Sustained generator operation under load could not be demonstrated. It is recommended that this be looked at by a qualified RV technician.

Illustration: Gasoline generator compartment; the loaded shutdown is described above.

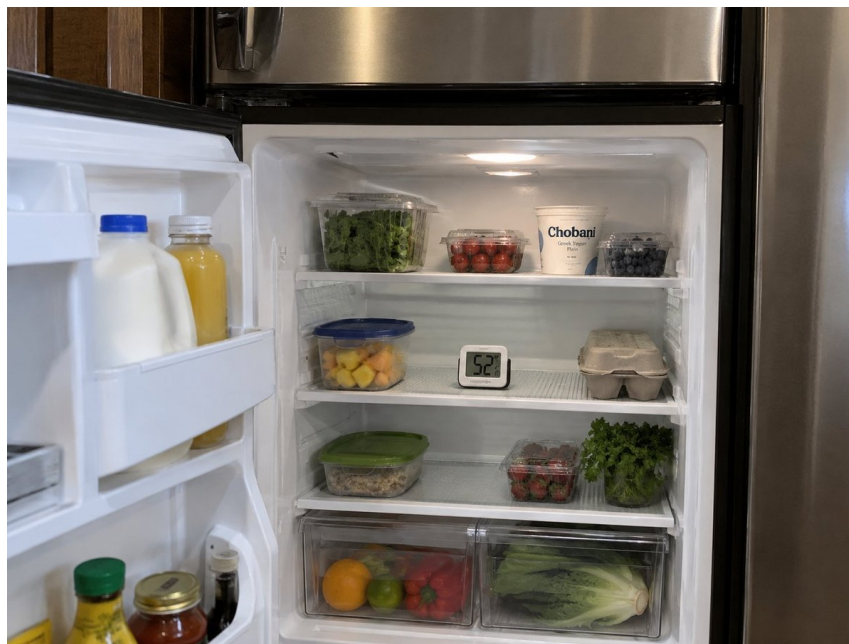
The residential refrigerator operated on 120-volt AC power, and its interior light and controls responded. After six hours of continuous operation with the doors kept closed between readings, the fresh-food compartment measured 52 F. Cooling was inadequate during the documented test period.

The residential refrigerator operated on 120-volt AC power, and its interior light and controls responded. After six hours of continuous operation with the doors kept closed between readings, the fresh-food compartment measured 52 F. Cooling was inadequate during the documented test period. It is recommended that this be looked at by a qualified RV technician.

Illustration: Residential refrigerator interior and temperature observation.

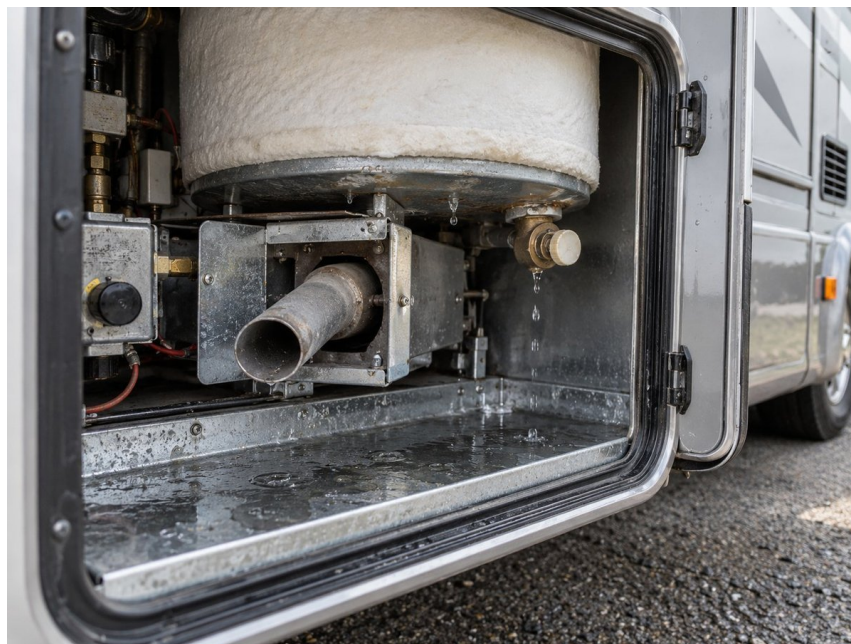
### 26.0 Water Heater - Condition

Water dripped from the lower water-heater area during testing on the electric heat source, and moisture accumulated in the exterior service tray. Water pressure and electric heat were turned off after the leak was observed. The exact internal source was not accessible. Propane heat was not tested.

Water dripped from the lower water-heater area during testing on the electric heat source, and moisture accumulated in the exterior service tray. Water pressure and electric heat were turned off after the leak was observed. The exact internal source was not accessible. Propane heat was not tested. It is recommended that this be looked at by a qualified RV technician.

Illustration: Water-heater service area and visible water accumulation.

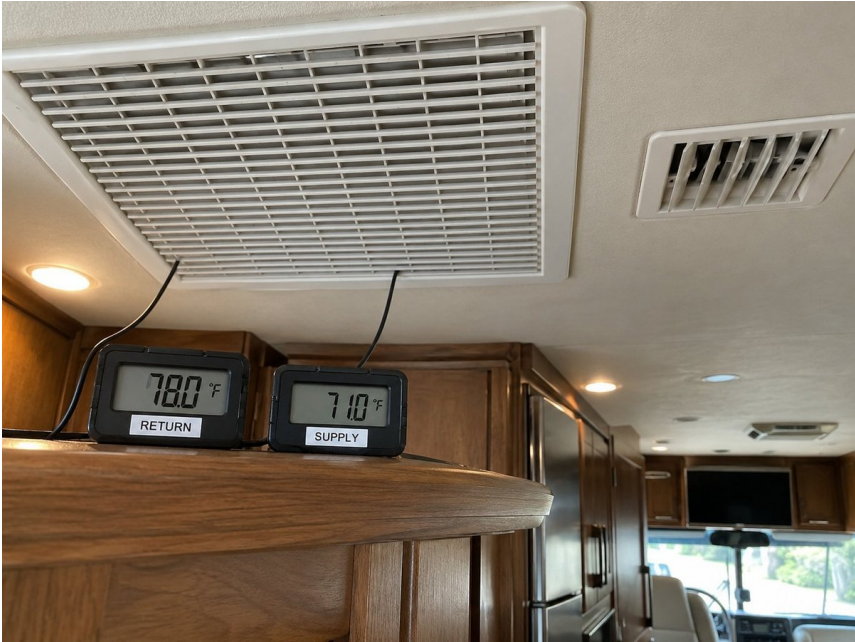
### 27.0 Front Air Conditioner - Condition

The front air conditioner fan and compressor operated, but cooling was limited during the test. After 20 minutes, return air measured 78 F and supply air measured 71 F, a 7 F difference. Measurements were taken at the accessible interior return and supply openings. The cause was not determined.

The front air conditioner fan and compressor operated, but cooling was limited during the test. After 20 minutes, return air measured 78 F and supply air measured 71 F, a 7 F difference. Measurements were taken at the accessible interior return and supply openings. The cause was not determined. It is recommended that this be looked at by a qualified RV technician.

Illustration: Interior return and supply temperature test setup: 78 F and 71 F.

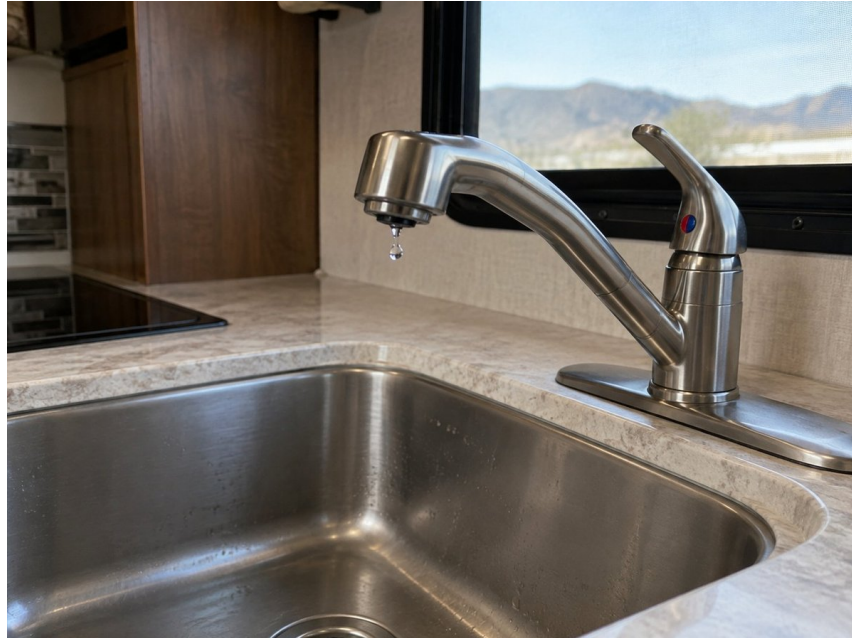
### 28.0 Kitchen Faucet - Operation and Condition

The kitchen faucet supplied water normally, but water continued to drip from the spout after the handle was moved to the off position. The countertop and visible supply connections were dry at the time of observation. It is recommended that this be looked at by a qualified RV technician.

Illustration: Drip at the kitchen faucet spout after shutoff.

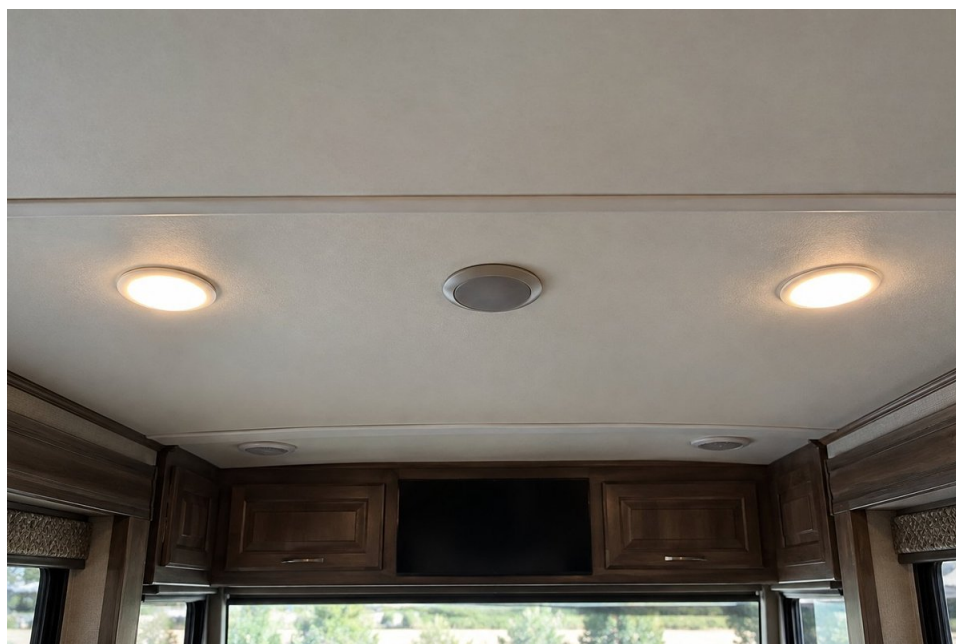
**29.19 Lights and Light Fixtures - 12-Volt DC Lights - Operation****Fair**

One living-area ceiling light did not illuminate when its switch was operated. Adjacent lights on the same switched group illuminated. The cause was not determined during the inspection.

One living-area ceiling light did not illuminate when its switch was operated. Adjacent lights on the same switched group illuminated. The cause was not determined during the inspection. It is recommended that this be looked at by a qualified RV technician.

Illustration: One dark ceiling lamp beside illuminated lamps.

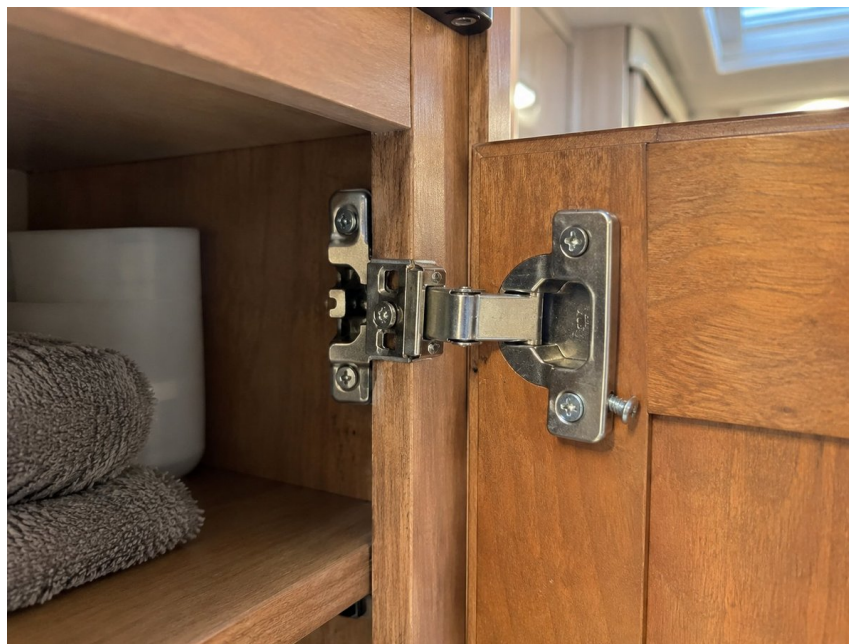
The upper hinge on a rear bathroom cabinet door was loose at its mounting point. The door moved out of alignment when opened. No extensive damage to the visible surrounding cabinet material was observed.

The upper hinge on a rear bathroom cabinet door was loose at its mounting point. The door moved out of alignment when opened. No extensive damage to the visible surrounding cabinet material was observed. It is recommended that this be looked at by a qualified RV technician.

Illustration: Loose bathroom cabinet hinge mounting.

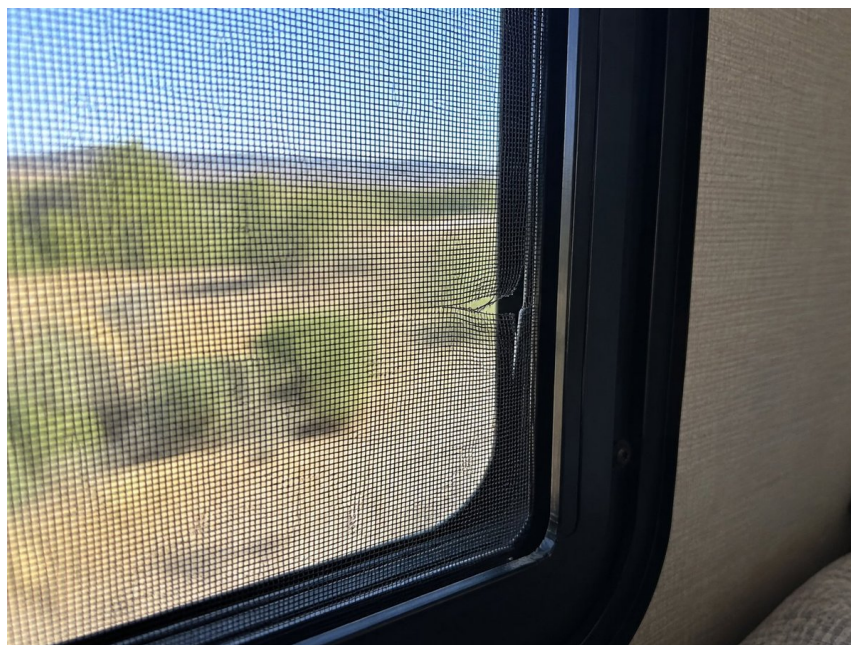
**29.48 Windows - Screens - Condition****Fair**

A small tear was observed in the mesh of the bedroom window screen. The frame remained in place, but the tear leaves an opening that can allow insects to enter. This is separate from the emergency exit window operation finding.

A small tear was observed in the mesh of the bedroom window screen. The frame remained in place, but the tear leaves an opening that can allow insects to enter. This is separate from the emergency exit window operation finding. It is recommended that this be looked at by a qualified RV technician.

Illustration: Tear in the bedroom window screen mesh.

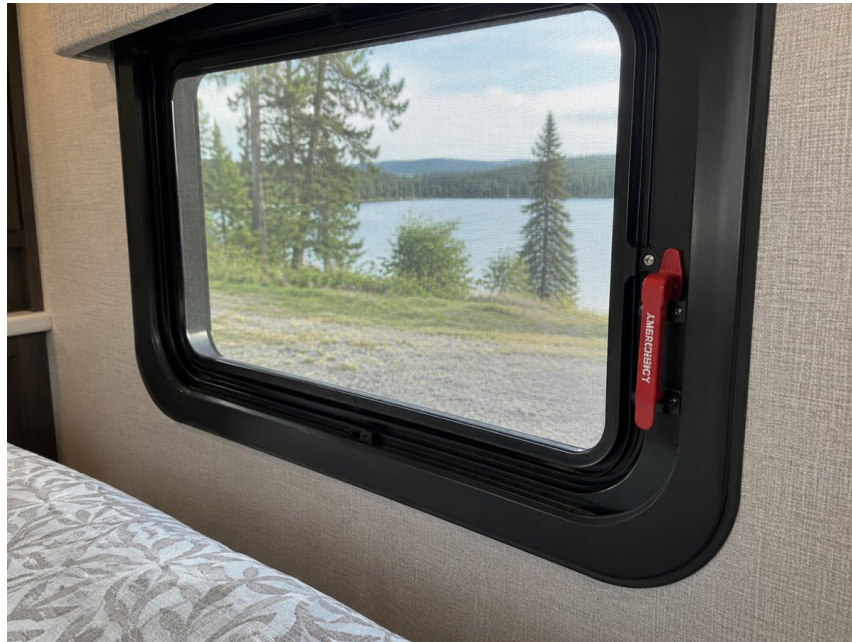
**29.49 Windows - Emergency Exit Windows - Operation****Poor**

The bedroom emergency exit window was present, but the window would not open after the release handle was operated. The opening could not be used as an emergency exit during the inspection. No force was applied that could damage the window.

The bedroom emergency exit window was present, but the window would not open after the release handle was operated. The opening could not be used as an emergency exit during the inspection. No force was applied that could damage the window. It is recommended that this be looked at by a qualified RV technician before the RV is occupied.

Illustration: Bedroom emergency exit window and release hardware; opening failure is described above.
