# RV INSPECTION REPORT

September 30, 2026 / 2024 Tiffin Open Road Allegro 36 LA

VIN: SYNTHETIC-36LA

Honest Mans Mobile RV Inspections

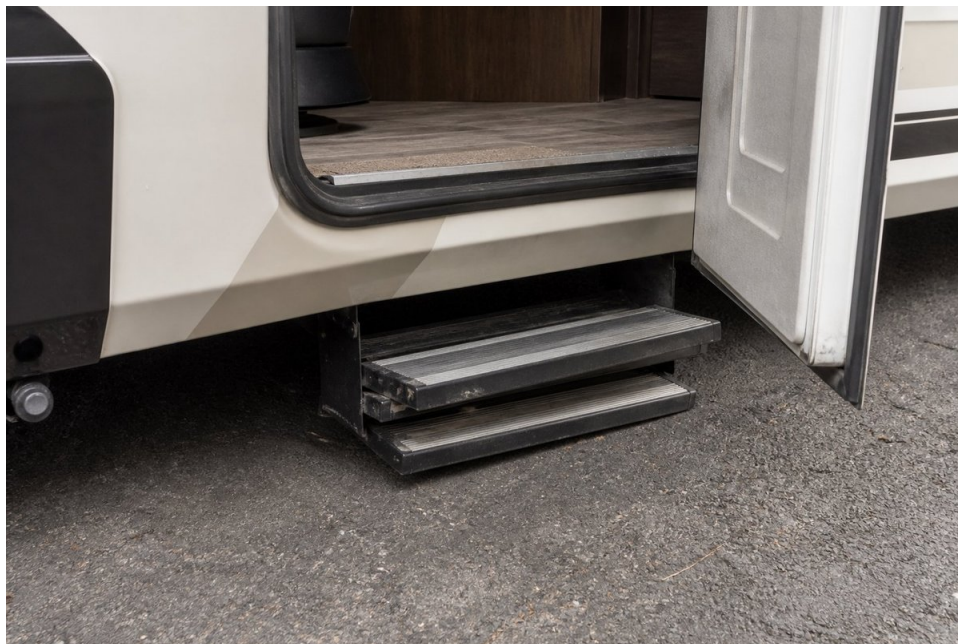
The accessible frame, surface and mounting points were visually reviewed. No additional damage or loose attachment was apparent. Concealed door reinforcement and internal hardware were not dismantled.

Illustration: Entry steps and threshold overview

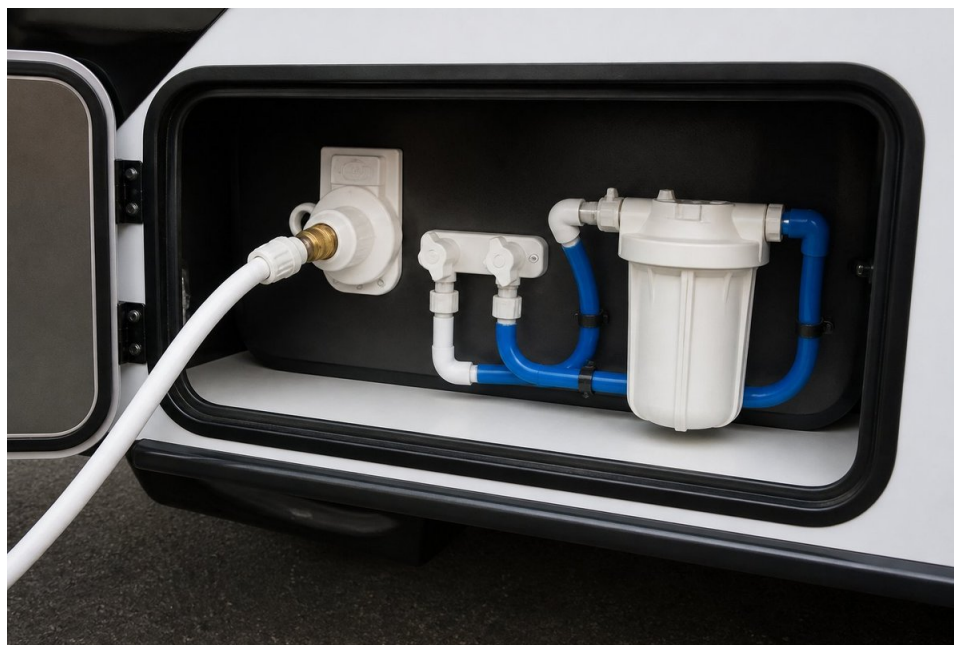
Illustration: City-water connection and filter compartment

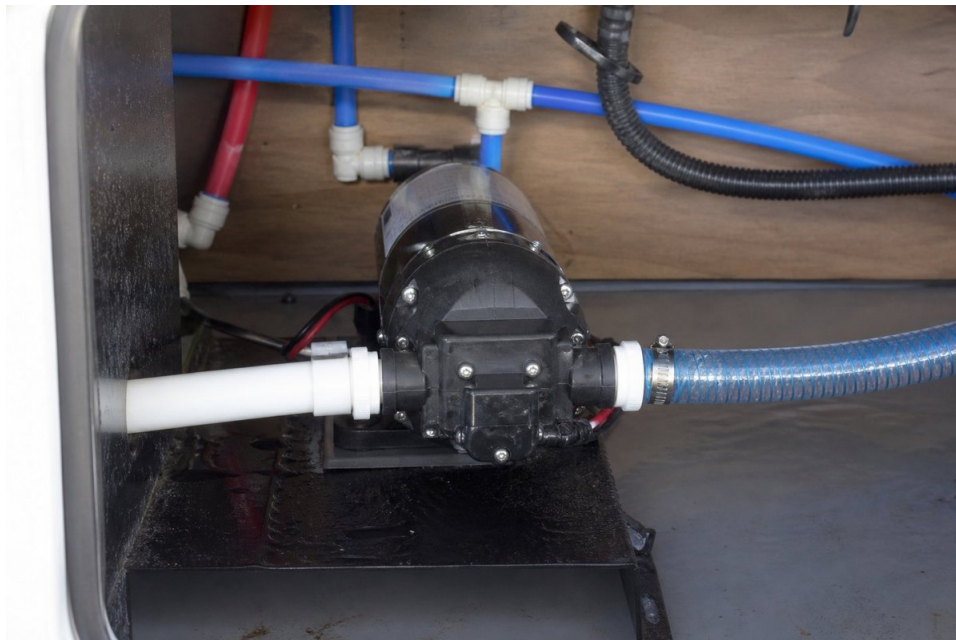
The system supplied water and held pressure during the observation period. No repeated pump cycling was noted with fixtures closed, and accessible connections remained dry. Concealed connections were not exposed.

Illustration: Accessible fresh-water pump and plumbing

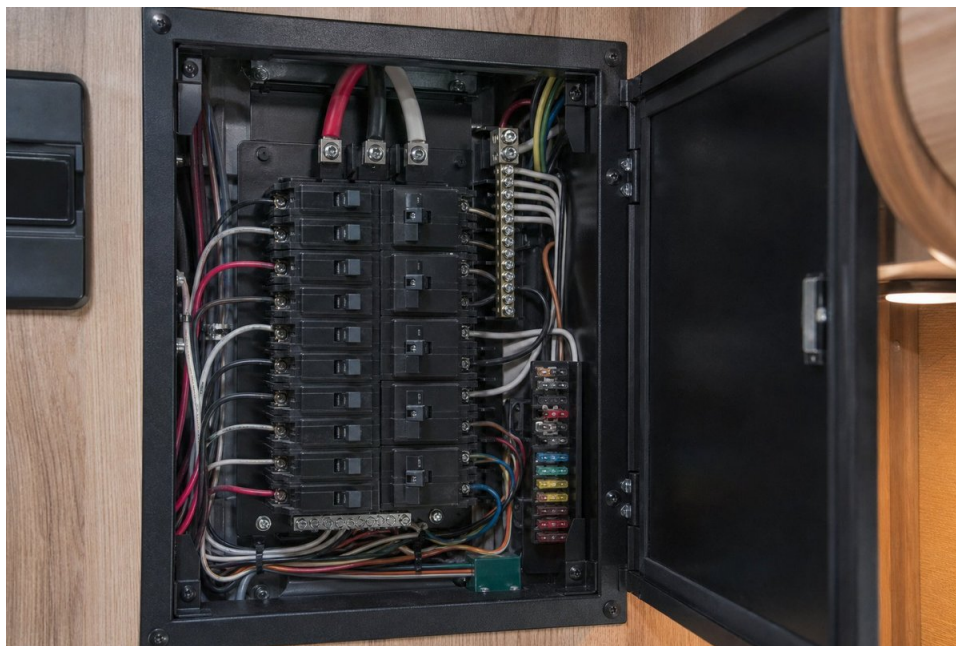
The accessible electrical component was visually reviewed or tested using its normal function. No additional defect was observed here. Circuit loading, concealed wiring and every hidden termination were not evaluated.

Illustration: Accessible electrical distribution panel overview

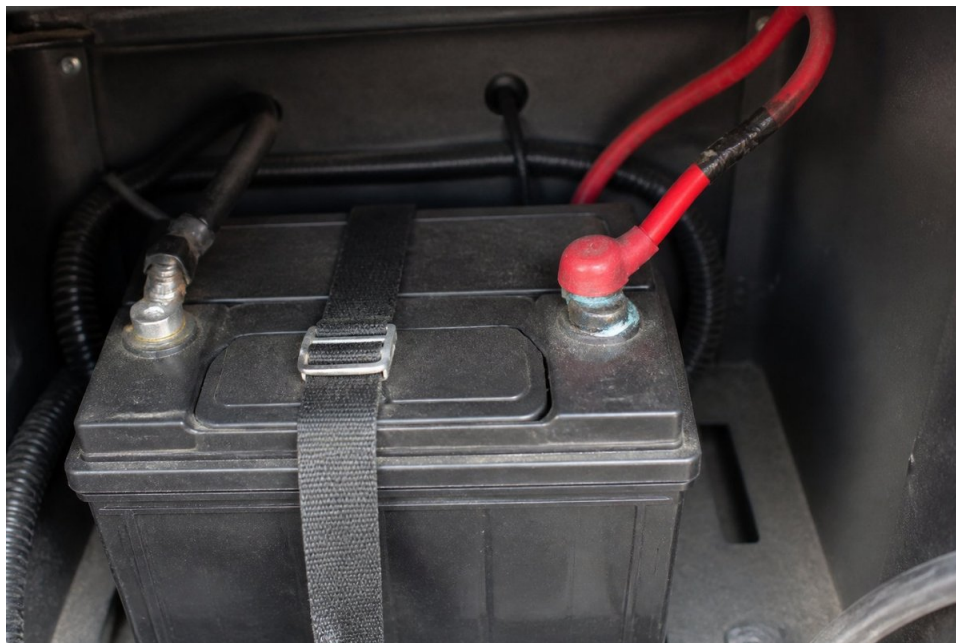
The accessible battery or inverter component was visually reviewed and its available indicator checked. Connections showed no obvious looseness or heat damage. A capacity discharge test and concealed-component examination were not performed.

Illustration: Battery terminal and cable connection illustration

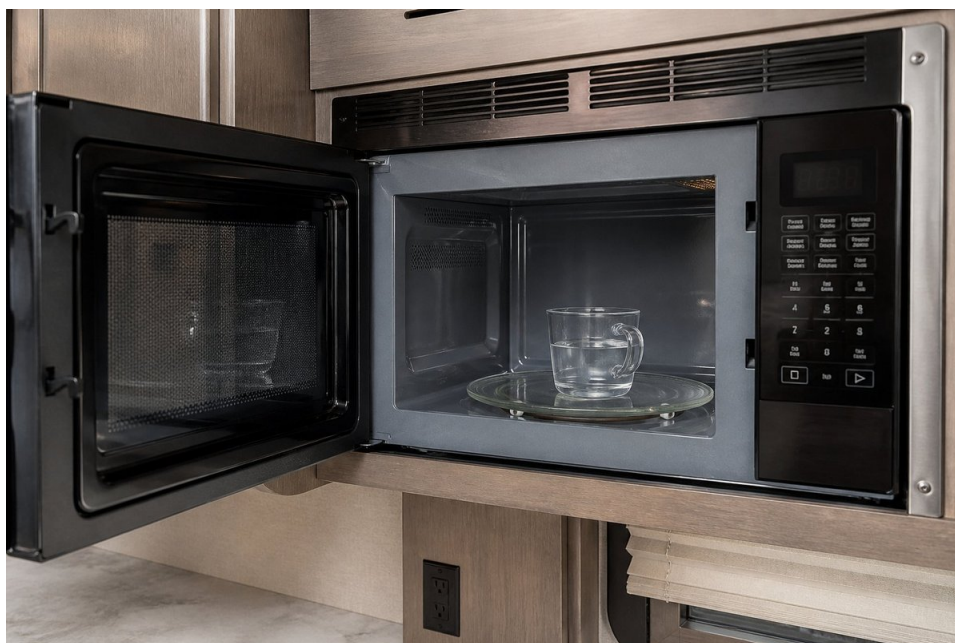
The microwave heated water during a brief functional test, and the convection fan operated. A full 350 F convection-temperature test was not performed.

Illustration: Microwave interior and water-heating test setup

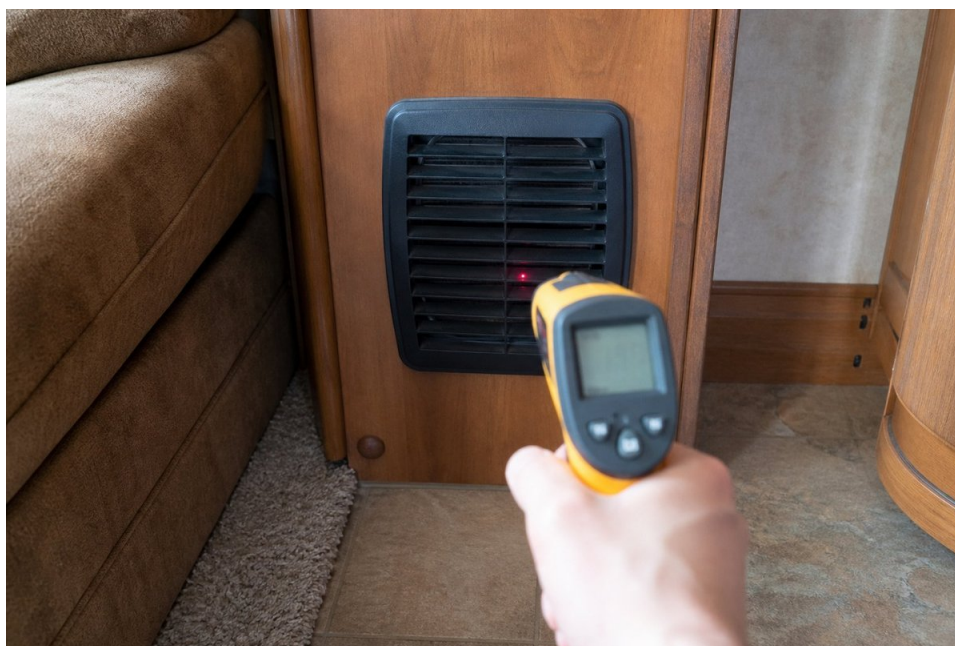
The accessible grille, return opening or exterior vent was reviewed visually. No obvious blockage was noted. Burner ignition and warm-air performance were not tested because propane remained shut off.

Illustration: Furnace grille location; illustration does not document a heat test

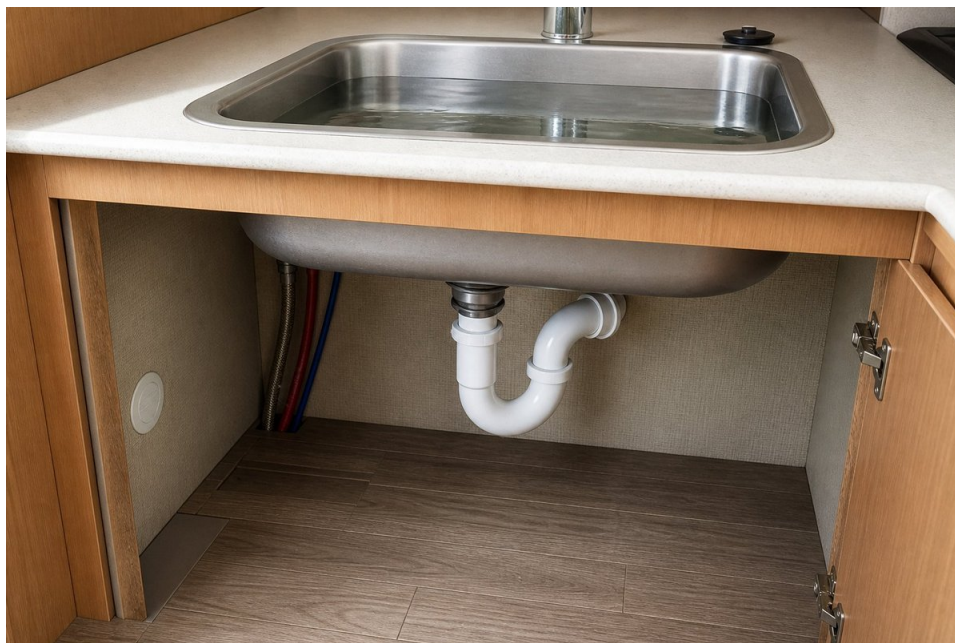
The accessible sink or connection was tested with clean water. The visible joint remained dry and the drain accepted flow.

Illustration: Sink drain and accessible under-sink plumbing

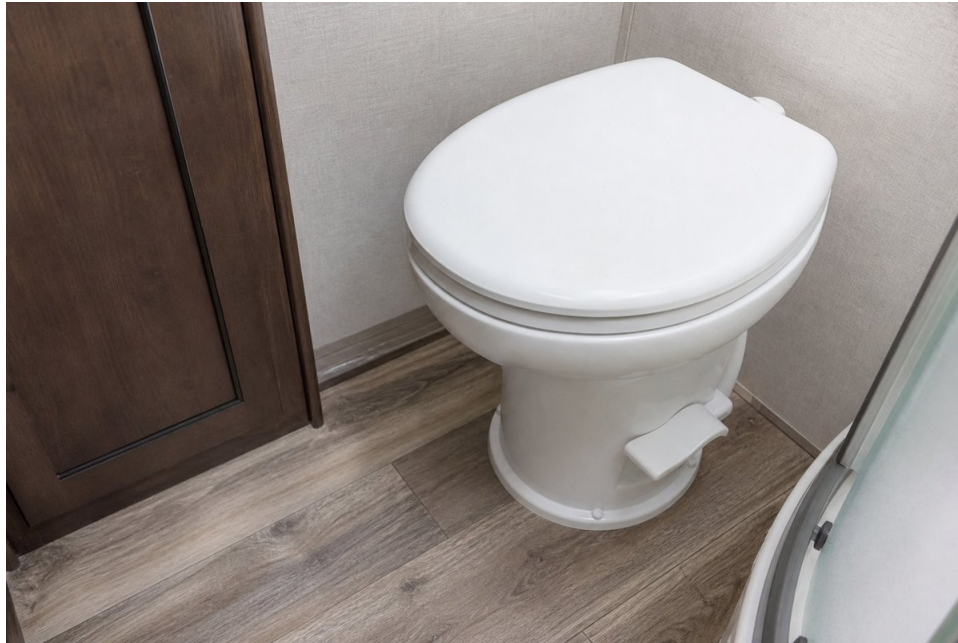
Illustration: Toilet and visible water connection

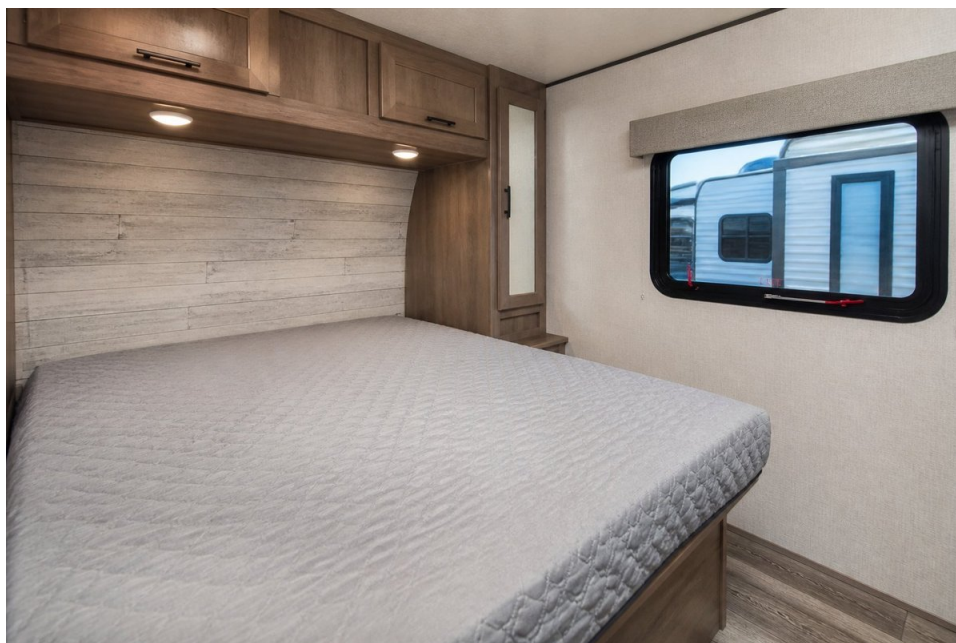
The bedroom emergency exit window was present, but the window would not open after the release handle was operated. The opening could not be used as an emergency exit during the inspection. No force was applied that could damage the window.

A designated bedroom emergency exit window was present. Presence does not establish usability: its failed opening test is separately reported as a Life Safety finding.

Illustration: Bedroom window location illustration; operation is reported separately

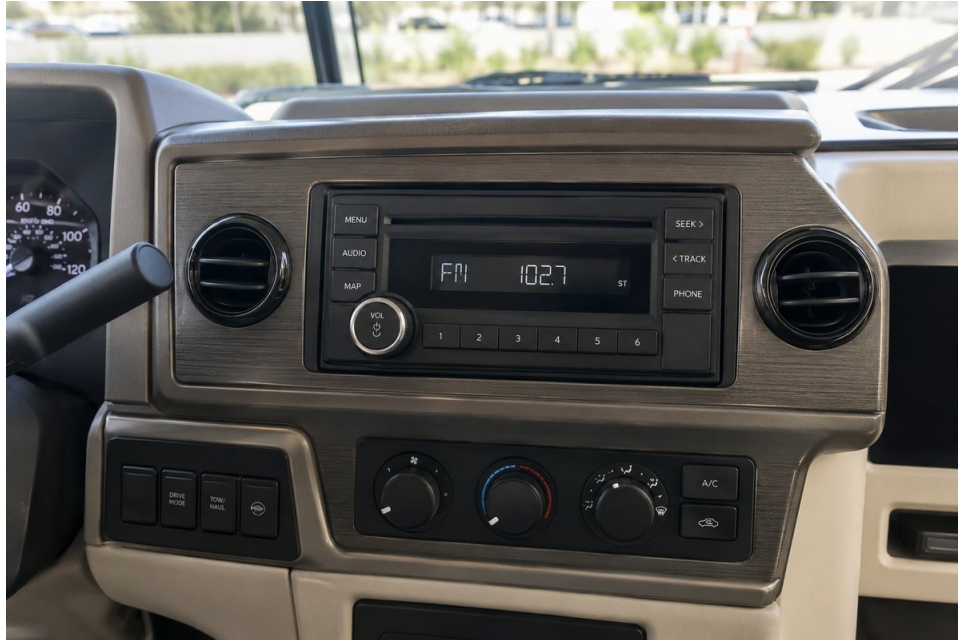
| <b>31.24 Radio / Stereo - Unit Works Properly</b><br><b>Acceptable</b><br>The radio/stereo powered on and produced sound during a basic functional test. Subscription services and reception at other locations were not verified. | |

Illustration: Dashboard radio/stereo powered on; sound response is described in the comment.
